HIGH ARCH BRIDGE:
A COST BENEFIT ANALYSIS OF PRESERVATION TECHNIQUES AS APPLIED
TO A VERNACULAR CONCRETE STRUCTURE

Ann Marie DiLucia

A THESIS

1998

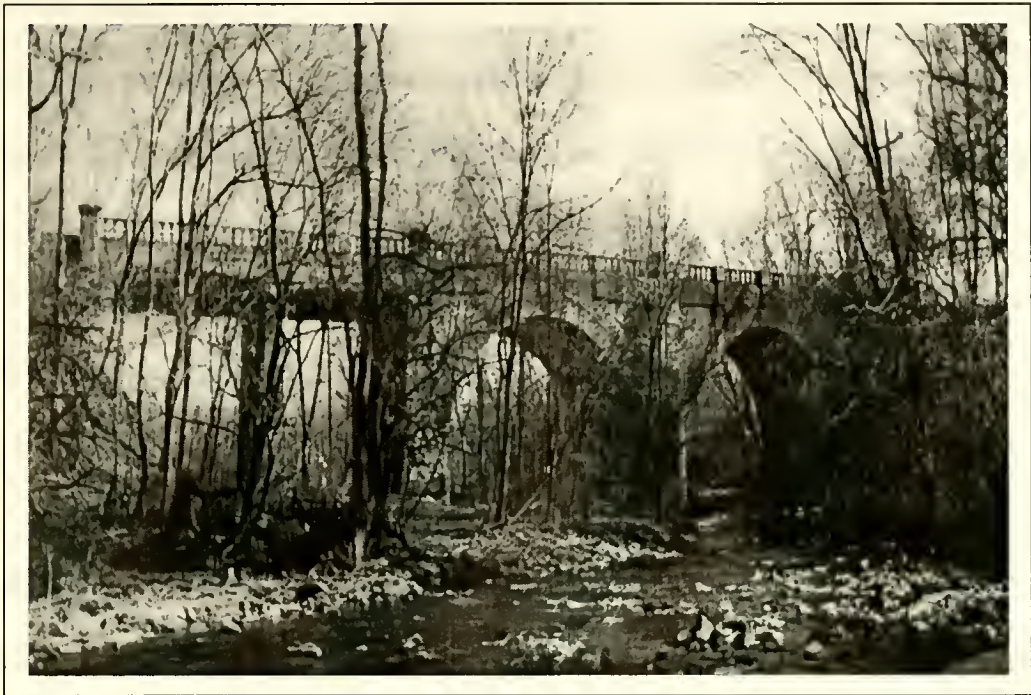
Observation of existing conditions reveals heavy losses of surface material, cracking, spalling, salt damage, and the effects of advanced freeze thaw cycling. The top portion of an abutment has crumbled away, and pieces of decorative elements lie in the creek below. Growth of a floodplain forest partially obscures view of the bridge from below, and vines have embedded themselves in another, still intact, abutment. Salt rings and water stains caused by drainage pipes cover the surface of the interior arches.

Figure 1 High Arch Bridge, west face.

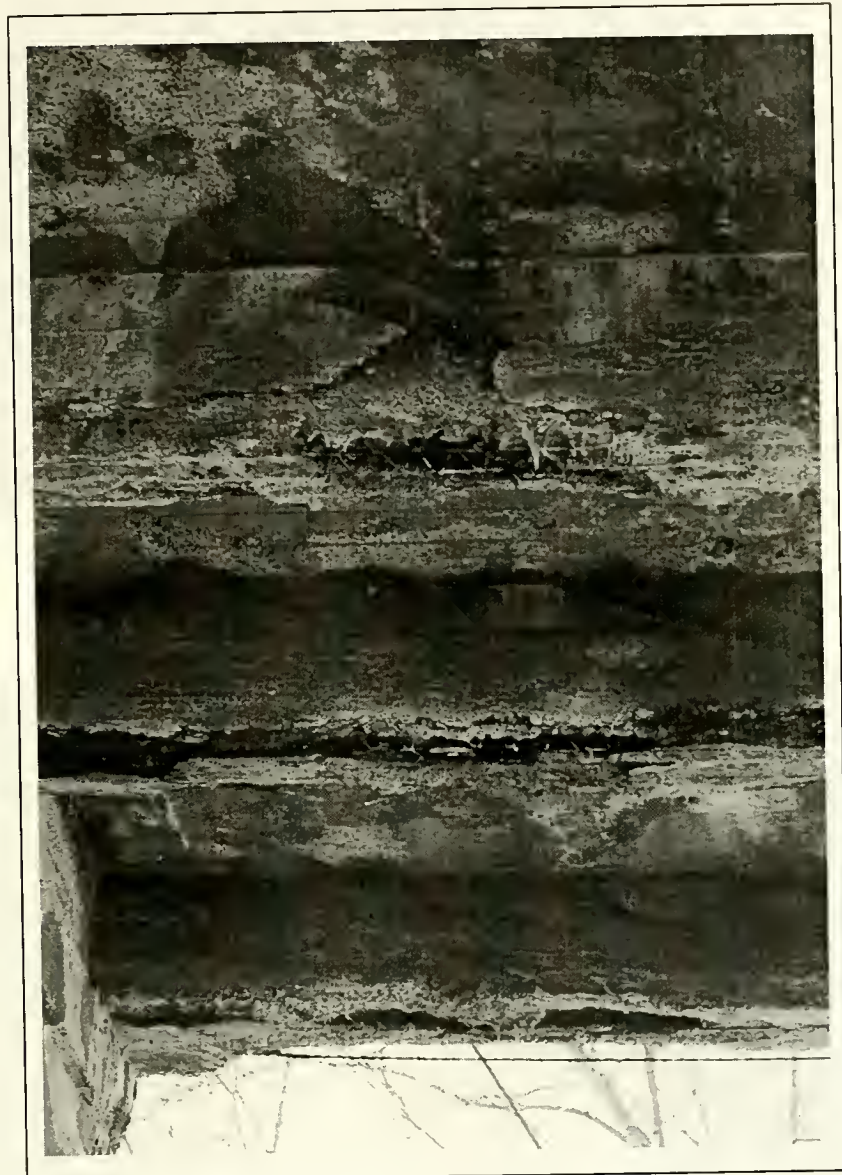
The corrosion of steel reinforcement is most visible in the superstructure of the bridge, specifically in the four I-beams that support the bridge deck through both straight spans (Figure 5). One-inch deformed steel rods in the piers of the structure have freed themselves from the concrete in which they were embedded, causing instability to architectural elements they had been designed to support (Figure 6). Exposed metal also protrudes from or is visible corroding within the upper rails of the balustrade (Figure 7). Dark stains on the balusters and posts in the parapet are a secondary failure caused by this corrosion.

Figure 5 Corrosion of I beam reinforcement.

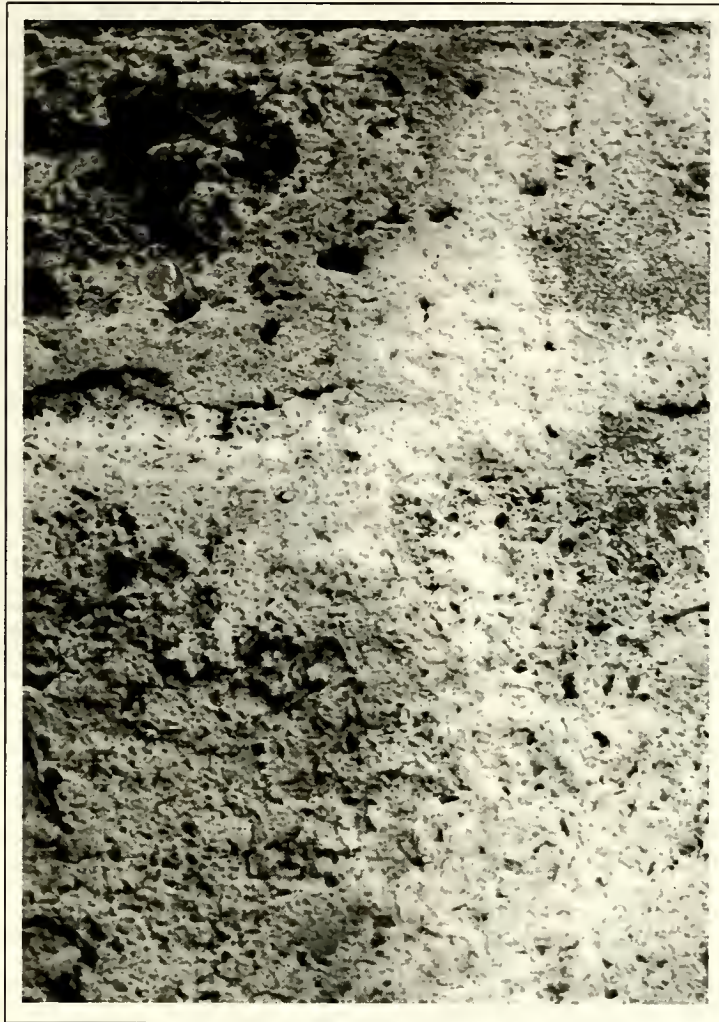
efflorescence and subflorescence. Heavy buildup of salts on the surface indicates large quantities present in the substrate (Figure 13).

Figure 13 Salts on surface of interior arch wall.

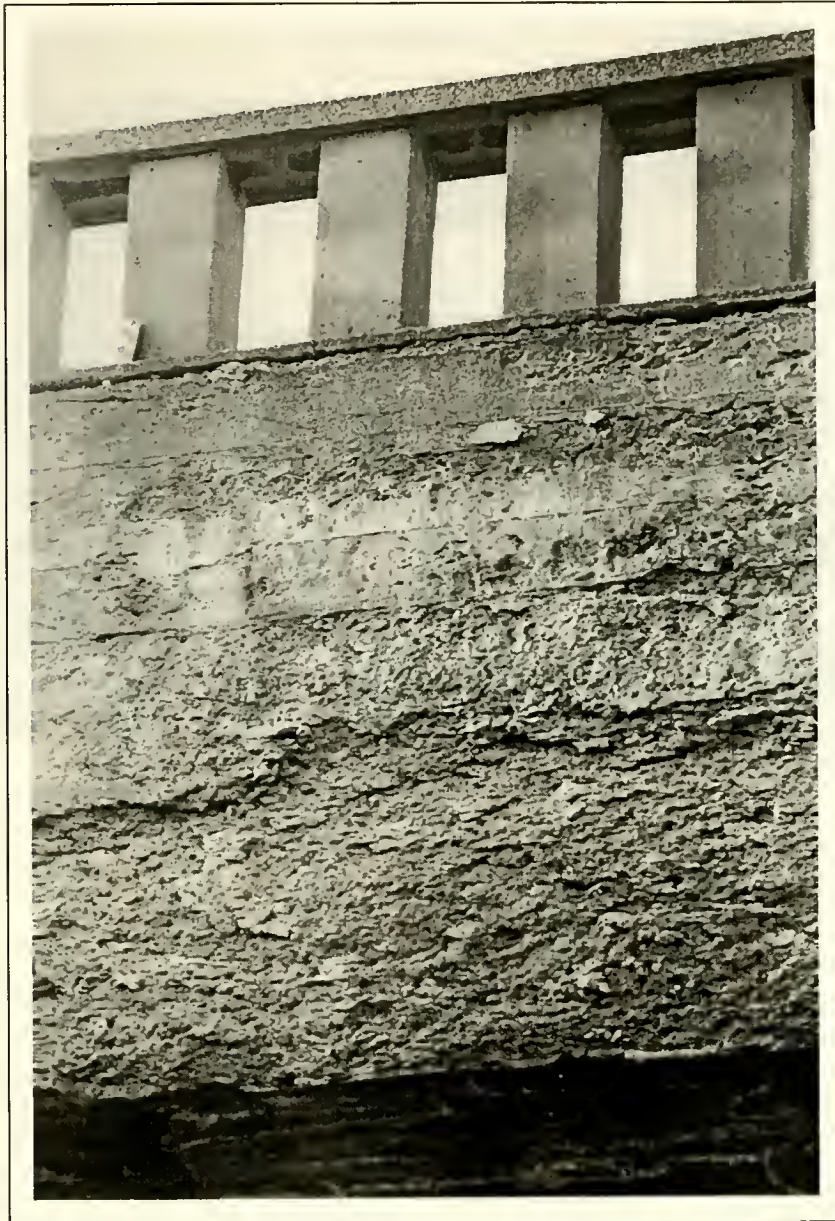
Finally, previous repair campaigns have created inconsistencies in the balustrade. Decorative balusters have been replaced in several areas with nine inch rectangular supports, an unfortunate circumstance causing aesthetic disharmony to the overall appearance of the bridge (Figure 16). In other sections of the balustrade, voids exist where no attempt was made to replace lost balusters (Figure 17). Integrity of the fabric and safety of the structure are jeopardized by these losses.

Figure 17 Rectangular replacement balusters
